Land Subsidence in the Upper Gila Area, Graham County
Based on Sentinel-1 Satellite Interferometric Synthetic Aperture Radar (InSAR) Data
Time Period of Analysis: 2.0 Years 04/15/2019 To 04/16/2021

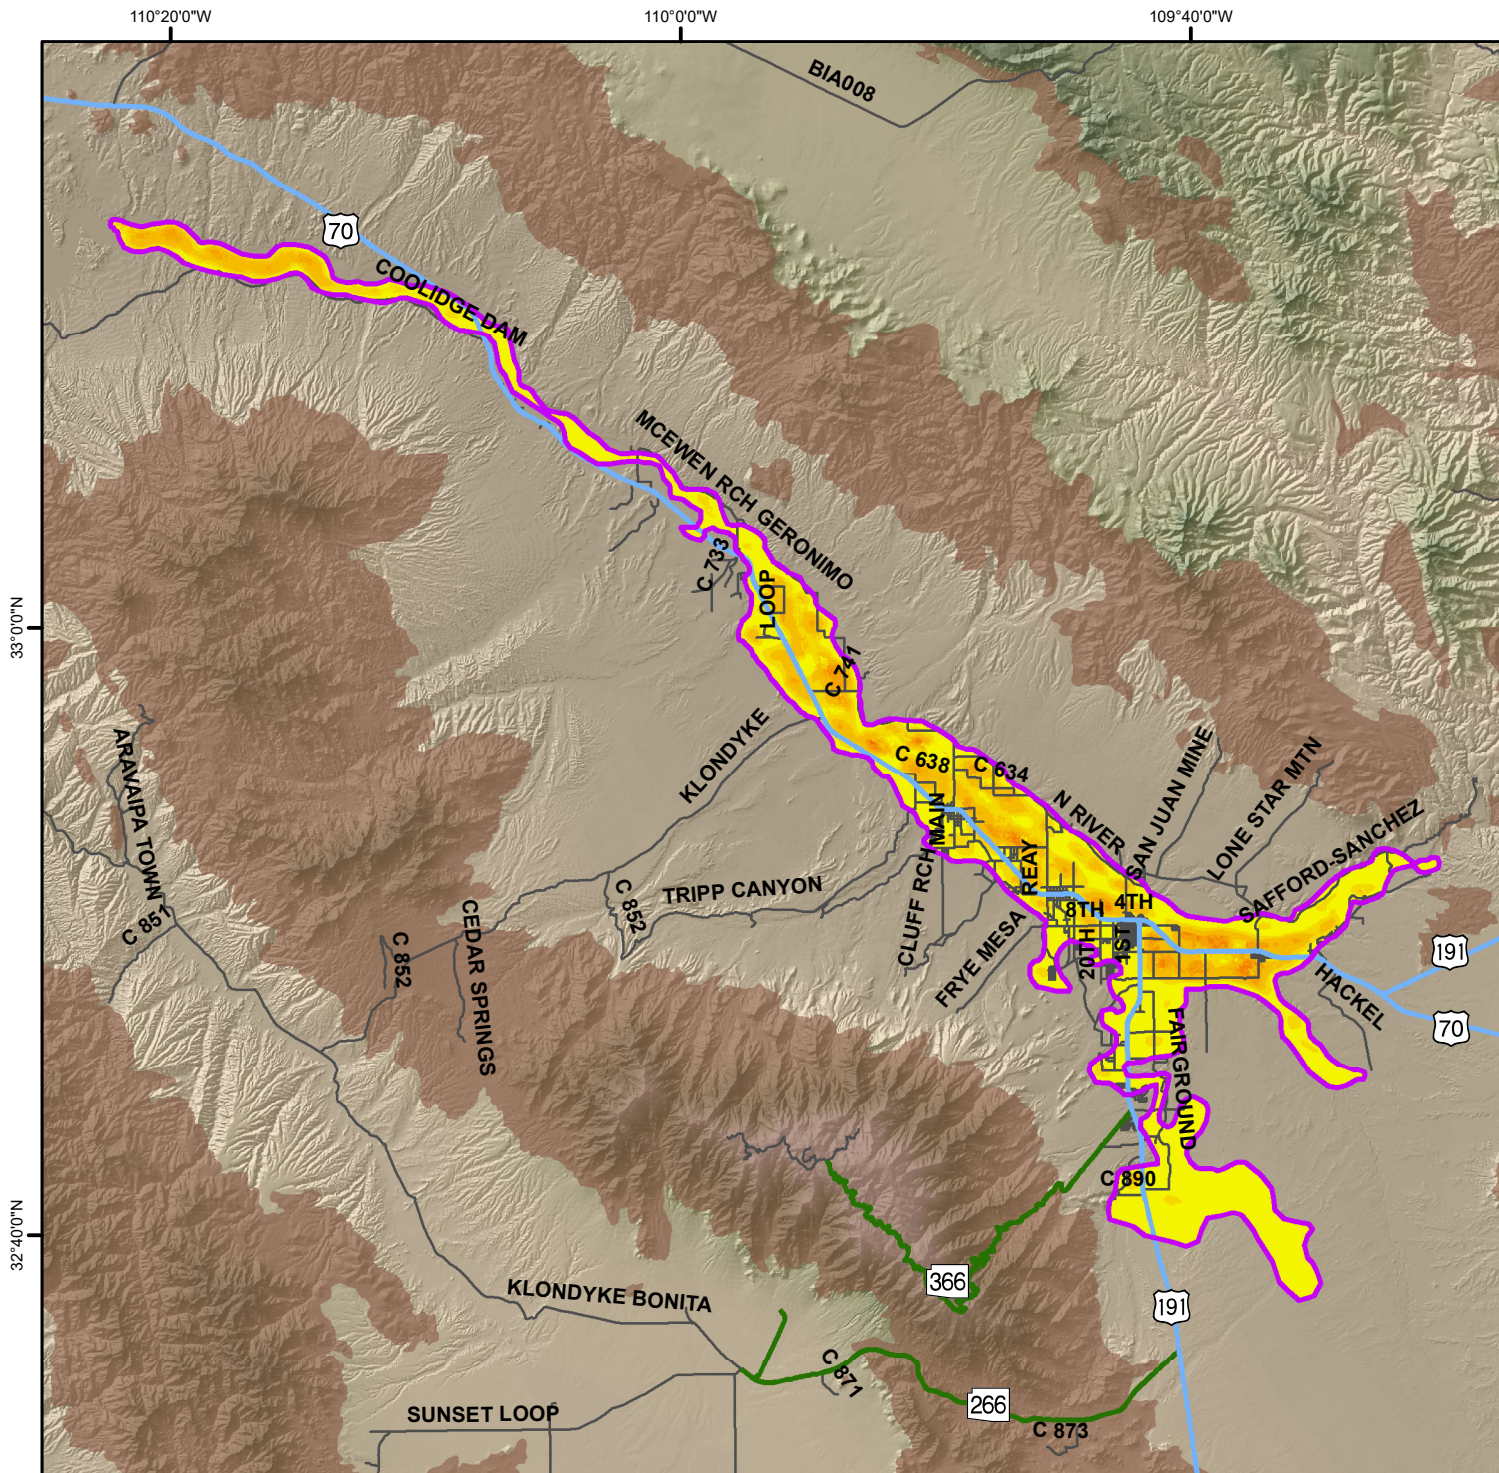
Total Land Subsidence

Decorrelation (white areas) are areas where the phase of the received satellite signal changed between satellite passes, causing the data to be unusable. This occurs in areas where the land surface has been disturbed (i.e. bodies of water, snow, agriculture areas, areas of development, etc).
